Historical Changes in Streamflows in the Rio Grande

Historical Changes in Channel and Riparian Features Downstream of Brownsville, Texas

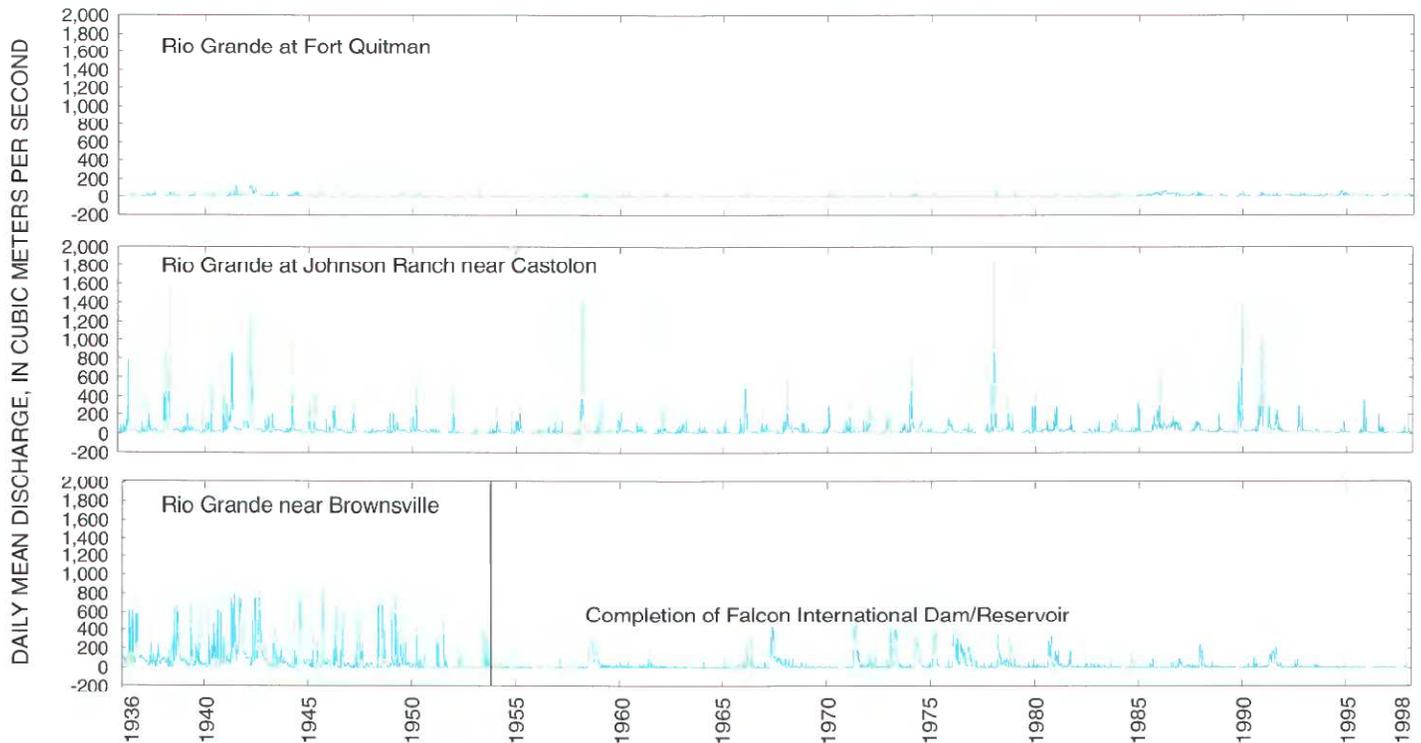
Figure 2. Hydrographs showing daily mean streamflow for three gaging stations on the Rio Grande.

Daily mean streamflow at the Fort Quitman station did not exceed 200 cubic meters per second during 1936–98 (fig. 2). This is partially a result of upstream reservoirs in New Mexico regulating flows. In contrast, daily mean streamflow is as great as 1,800 cubic meters per second at the Johnson Ranch station, which is downstream of the confluence with the Río Conchos (fig. 1). Flows at the Johnson Ranch station are more seasonal than flows at the Fort Quitman station, with increased flows in late summer corresponding to the onset of monsoonal rains in the Chihuahuan Desert. These seasonal flows reflect the flow of the Río Conchos, which is less regulated than the Rio Grande above El Paso. The streamflow record for the station just downstream from Brownsville (fig. 2) shows that the variability in flows decreased substantially after the completion of Falcon International Reservoir in 1958. In particular, the proportion of flows greater than 100 cubic meters per second decreased

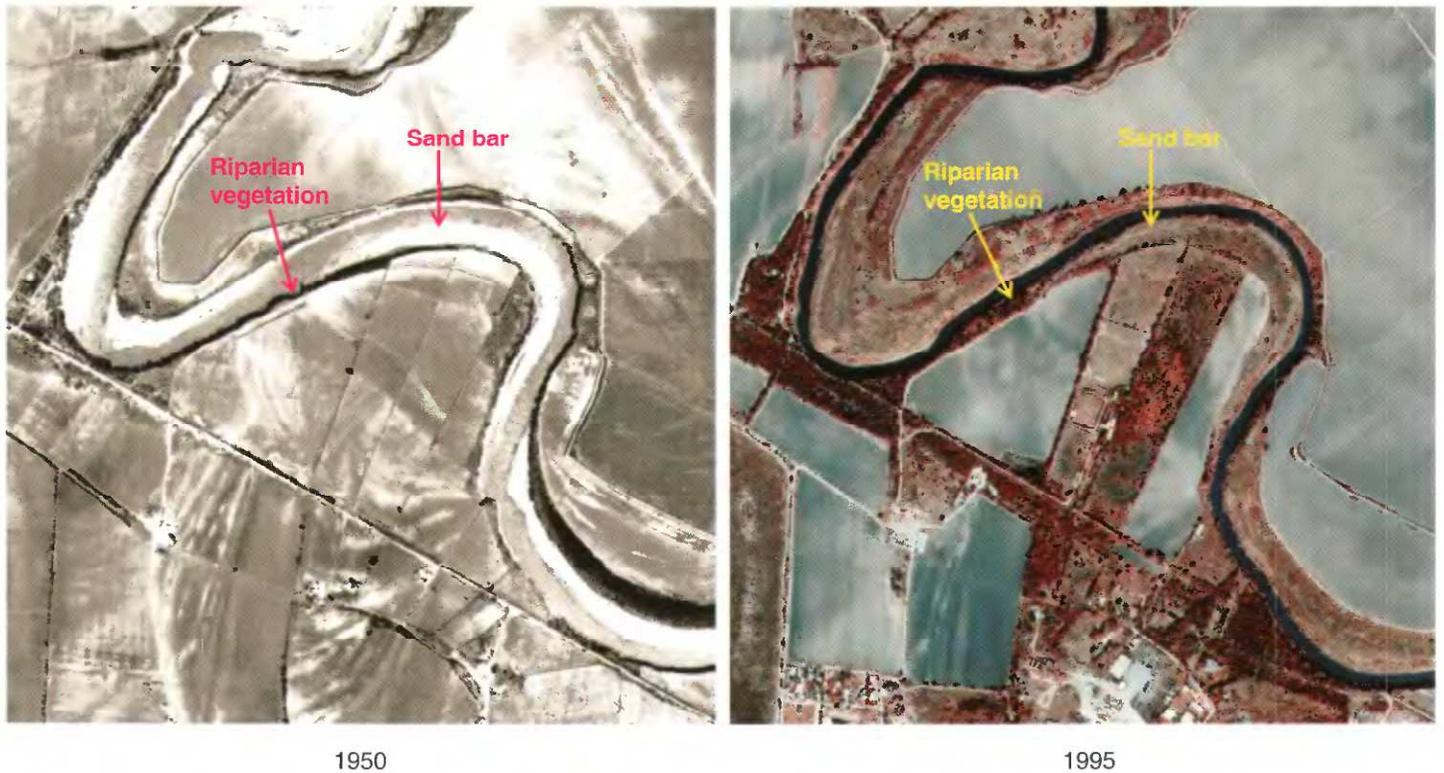
Figure 4. 1950 and 1995 aerial photographs of part of segment of the Rio Grande downstream of Brownsville, Texas.

These changes in channel and riparian features in this segment of the Rio Grande downstream of Brownsville are further illustrated by comparing the 1950 aerial photograph

to the 1995 aerial photograph for a part of the segment studied (fig. 4). Point bars in the 1950 photograph are primarily unvegetated sand. The same point bars in the 1995 photograph have little or no sand visible and are largely covered with vegetation. The channel in the 1995 photograph is visibly narrower and is more simplified than the channel in the 1950 photograph.
