In cooperation with the Nevada Department of Transportation

Flood of July 8, 1999, in Las Vegas Valley, southern Nevada

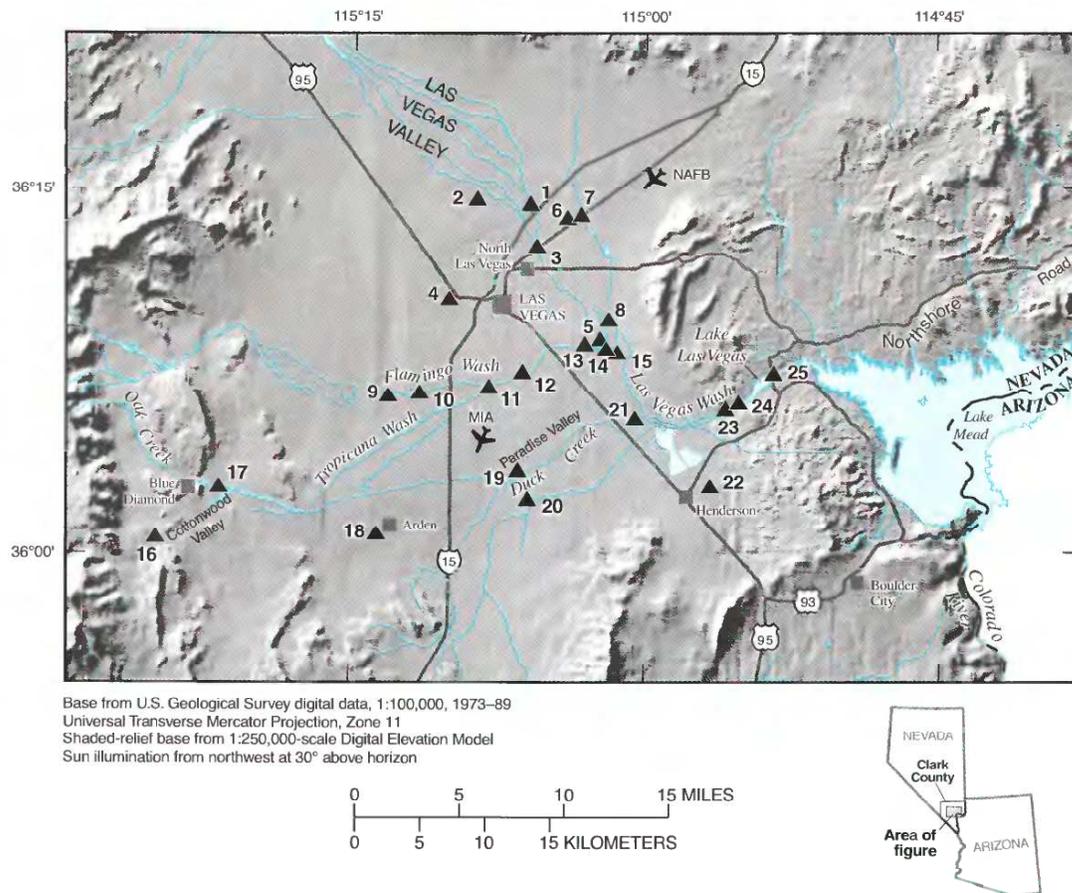
Figure 1. Geographic and hydrologic features in Las Vegas Valley, southern Nevada. Triangles locate streamflow-gaging stations; labels indicate site numbers used in report. MIA, McCarran International Airport; NAFB, Nellis Air Force Base.

The U.S. Geological Survey operates a network of streamflow-gaging stations (Fig. 1) in Clark County in cooperation with the Nevada Department of Transportation and other Federal, State, and local agencies. Data from the stations are crucial for water-supply planning, flood monitoring and warning, emergency response, dam and reservoir-system operation, establishing flood-insurance rates, and engineering and maintenance of bridges, roads, and other structures.

Information on peak discharges for selected gaging stations (Fig. 1) in Las Vegas Valley is shown in the accompanying table. The data include July 1999 peak discharges, gaging-station period of record, and date and magnitude of the largest historical peak discharge recorded prior to July 1999 (Kane and Wilson, 2000).

Runoff from the storm occurred in nearly all the tributaries to Las Vegas Wash. Peak flows for the period of record occurred in Duck Creek (sites 19 and 21, Fig. 1), Flamingo Wash (sites 12 and 13), Bird Spring wash (site 18), and North Las Vegas detention-basin outlet (site 1). At Flamingo Wash at Eastern Avenue (site 12) a peak flow of 6,800 cubic feet per second was the highest measured since 1969. Peak flows along Las Vegas Wash were measured also at Las Vegas Wash near Sahara Avenue (site 5), below Flamingo Wash confluence (site 14), at Vegas Valley Drive (site 15), above Three Kids wash (site 22), and at Las Vegas Wash overflow at Lake Las Vegas inlet (site 23; Fig. 2). A peak flow of 18,000 cubic feet per second at Las Vegas Wash above Three Kids wash was the highest measured in Las Vegas Wash for more than 40 years. At Las Vegas Wash near Boulder City (site 24; Fig. 3), a peak flow was estimated to be 10,700 cubic feet per second, which included the combined flows of Las Vegas Wash through the bypass conduit and Lake Las Vegas spillways (Steven Weber, Lake Las Vegas Resort, oral commun., 1999).

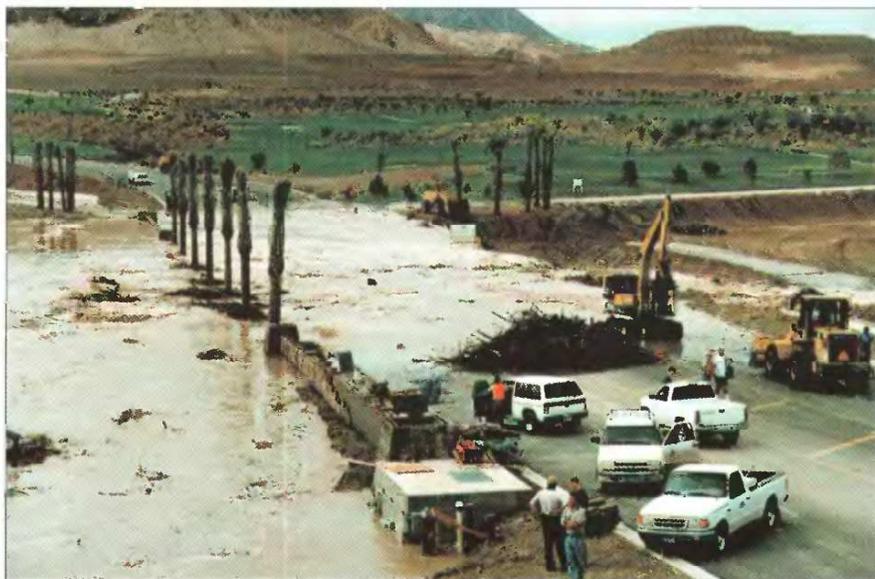
Figure 2. Views of Las Vegas Wash overflow at Lake Las Vegas inlet (site 24, Fig. 1), July 8, 1999, showing floodwaters (near peak flow, 17,000 cubic feet per second) discharging into lake through culvert structure and over road. Photograph by David Beck, U.S. Geological Survey.

U.S. Geological Survey field crews obtained some of the highest discharge (flow) measurements ever recorded at several gaging stations within the Las Vegas Wash drainage basin during the July 8, 1999, flood (Fig. 2). Hydraulic surveys were made immediately after the flood to determine peak discharge at stations where field crews were unable to obtain discharge measurements during the high flows. The data contribute to understanding flood behavior, enhance efforts to minimize destruction caused by floods, and provide data for planning.

Resort¹. Street flooding was widespread in the valley as multiple intersections and major streets pooled or channeled runoff. Flamingo Wash had extensive channel scour and sediment deposition upstream from its confluence with Las Vegas Wash. Several homes and businesses in the Flamingo Wash drainage were damaged or destroyed when flow in Flamingo Wash left its channel and eroded its stream banks (Koch and Radke, 1999; Radke, 1999). At the Lake Las Vegas¹ dam, streamflow exceeded the capacity of the two bypass conduits and the overflow culverts and flowed over the road into the lake (Fig. 2).

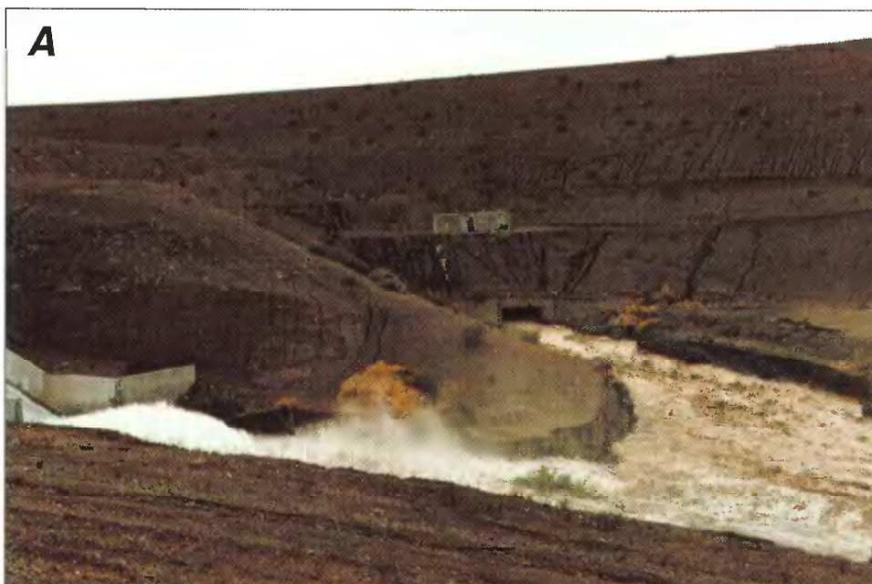
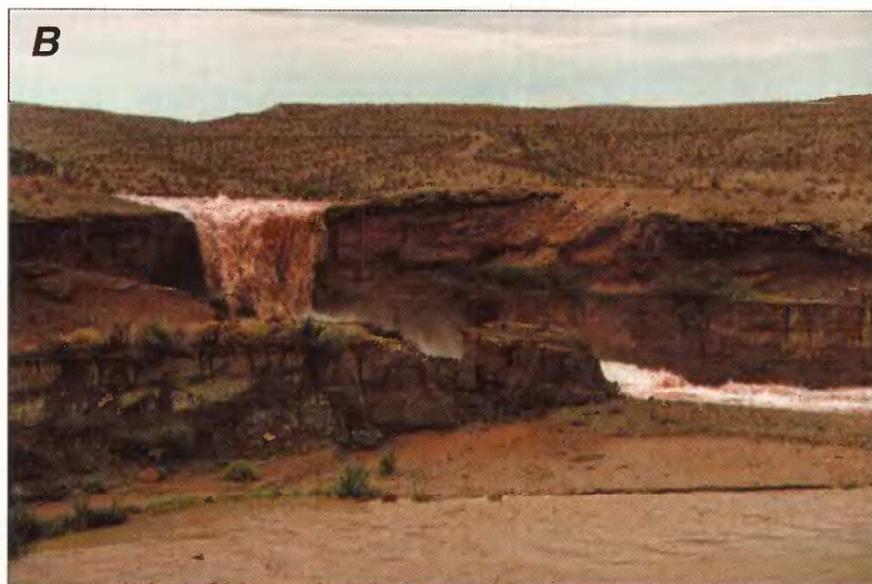
Figure 3. Las Vegas Wash near Boulder City (site 25, Fig. 1), looking upstream from Northshore Road bridge, showing estimated peak outflow of 10,700 cubic feet per second from Lake Las Vegas and Las Vegas Wash. Photographs taken by David Beck. U.S. Geological Survey. *A*, Lake Las Vegas overflow service spillway (left) and Las Vegas Wash outflow conduit (right). *B*, Lake Las Vegas overflow auxiliary spillway.
